**99-7510 / 95-7510**

We receive frequent customer calls about early model (2004-2008) RX8's with problems relating to the A/C temperature control. The complaint ranges from no heat, no cooling, to erratic temperature control. Users often relate the issue to the installation of the 99-7510 installation kit and its variants.

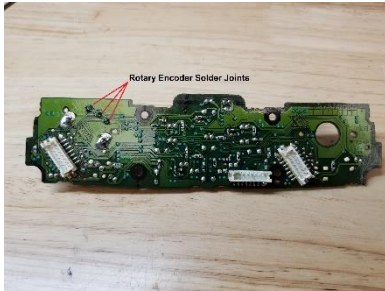
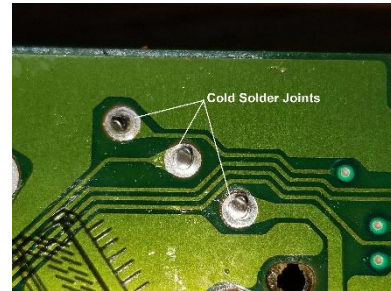
In actuality, the problem stems from a very common issue with the OEM A/C control module. The solder joints connecting the rotary encoder (knob) to the circuit board were soldered poorly from the factory. Time, vibration, heat cycles and use can cause the connections between the knob and board to develop hairline cracks that prevent the control from properly communicating to the A/C blend motor. This is known as cold solder joints. Due to the frequently intermittent nature of the problem, it may seem that the process of swapping between factory and aftermarket radios affects the problem, but it is very common for vehicles with the factory radio still installed to develop the same symptom. The install kit is not related to the problem at all.

**Step 7)** Locate the 3 solder joints connecting the rotary encoder to the circuit board and examine them for integrity. They will probably look dull and may show evidence of cracks or breaks. This is the cause of the control issue and what needs to be resoldered.

**Step 8)** The best practice is to remove the old solder using a vacuum extraction device (Solder Sucker) or solder wick before resoldering, but it is possible to add new solder and flux to reflow the joint. It is important to use a high-quality electronic solder with a rosin core and a flux designed for electronic soldering. Solders designed for other purposes like plumbing may have corrosive flux or an alloy that requires more heat than the circuit board and components can withstand. A soldering iron around 30W with a fine tip and temperature control should be used to control the heat applied.

To make the repair, the joint should be heated with the iron, and fresh solder flowed in. When properly executed, the joint should look smooth and shiny, with the solder blended into the board. It should not look like a ball on top of the connection.
