TE-BSDK Update

Symptoms experienced that will require the update, the TE-BSDK will produce an audible sound and flash regardless of which trigger was used. This means that if you have the left trigger activated, and the sensor on the right detects an object, the audible tone will alert, even though you're only expecting feedback if there is something detected by the left sensor.

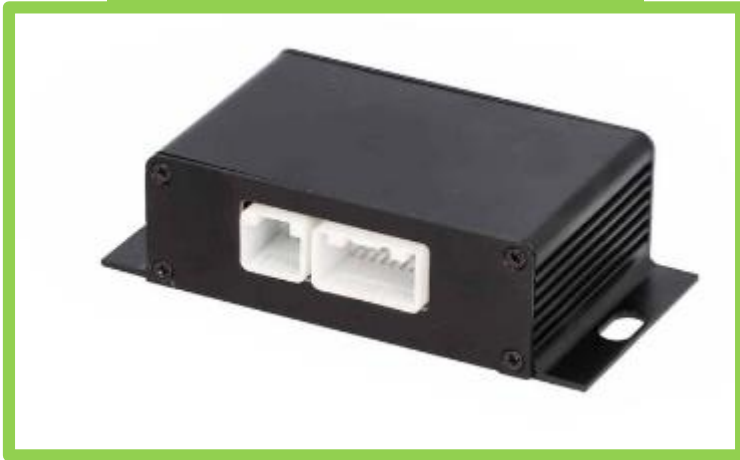
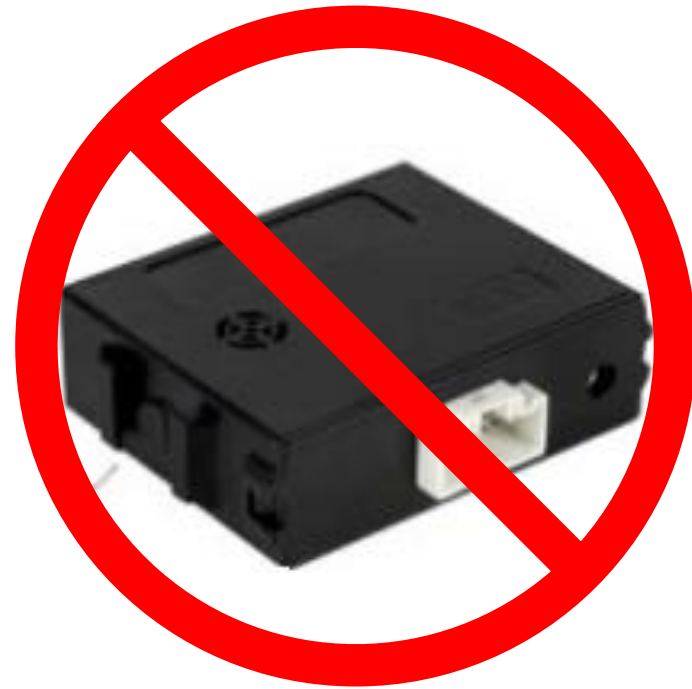
The unit that will require the update.

Update is for this design.

This is how to update your TE-BSDK to correct this issue.
